Name of Dam: South River No. 26
Location: Augusta County, State of Virginia
Inventory Number: VA 01501

PHASE I INSPECTION REPORT
NATIONAL DAM SAFETY PROGRAM

Name of Dam: South River No. 26
State: Virginia
County: Augusta
USGS 7.5 Minute Quadrangle: Waynesboro West, VA
Stream: Inch Branch
Date of Inspection: 27 November 1979

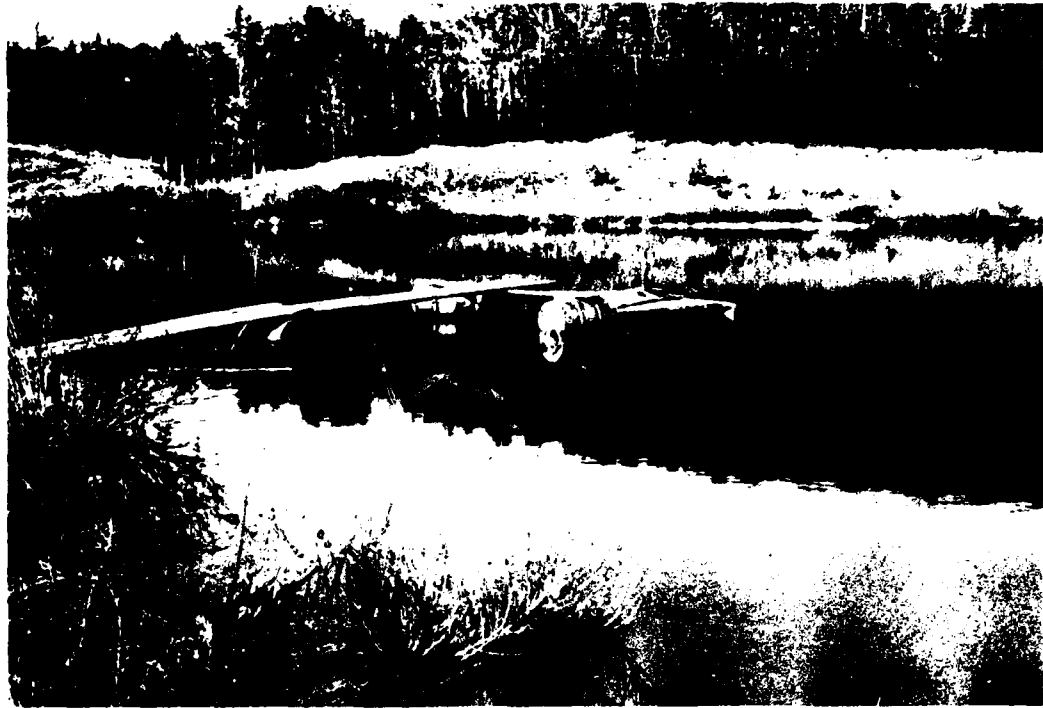
PHOTO 1. Principal Spillway Intake
